ADVANCED ELECTROMECHANICAL ACTUATION SYSTEM (EMAS)
FLIGHT TEST

William J. Norton, First Lieutenant, USAF
Advanced Aircraft Systems Branch
Aircraft and Avionics Division
Directorate of Flight Test Engineering

June 1986

Final Report for Period July 1985 - March 1986

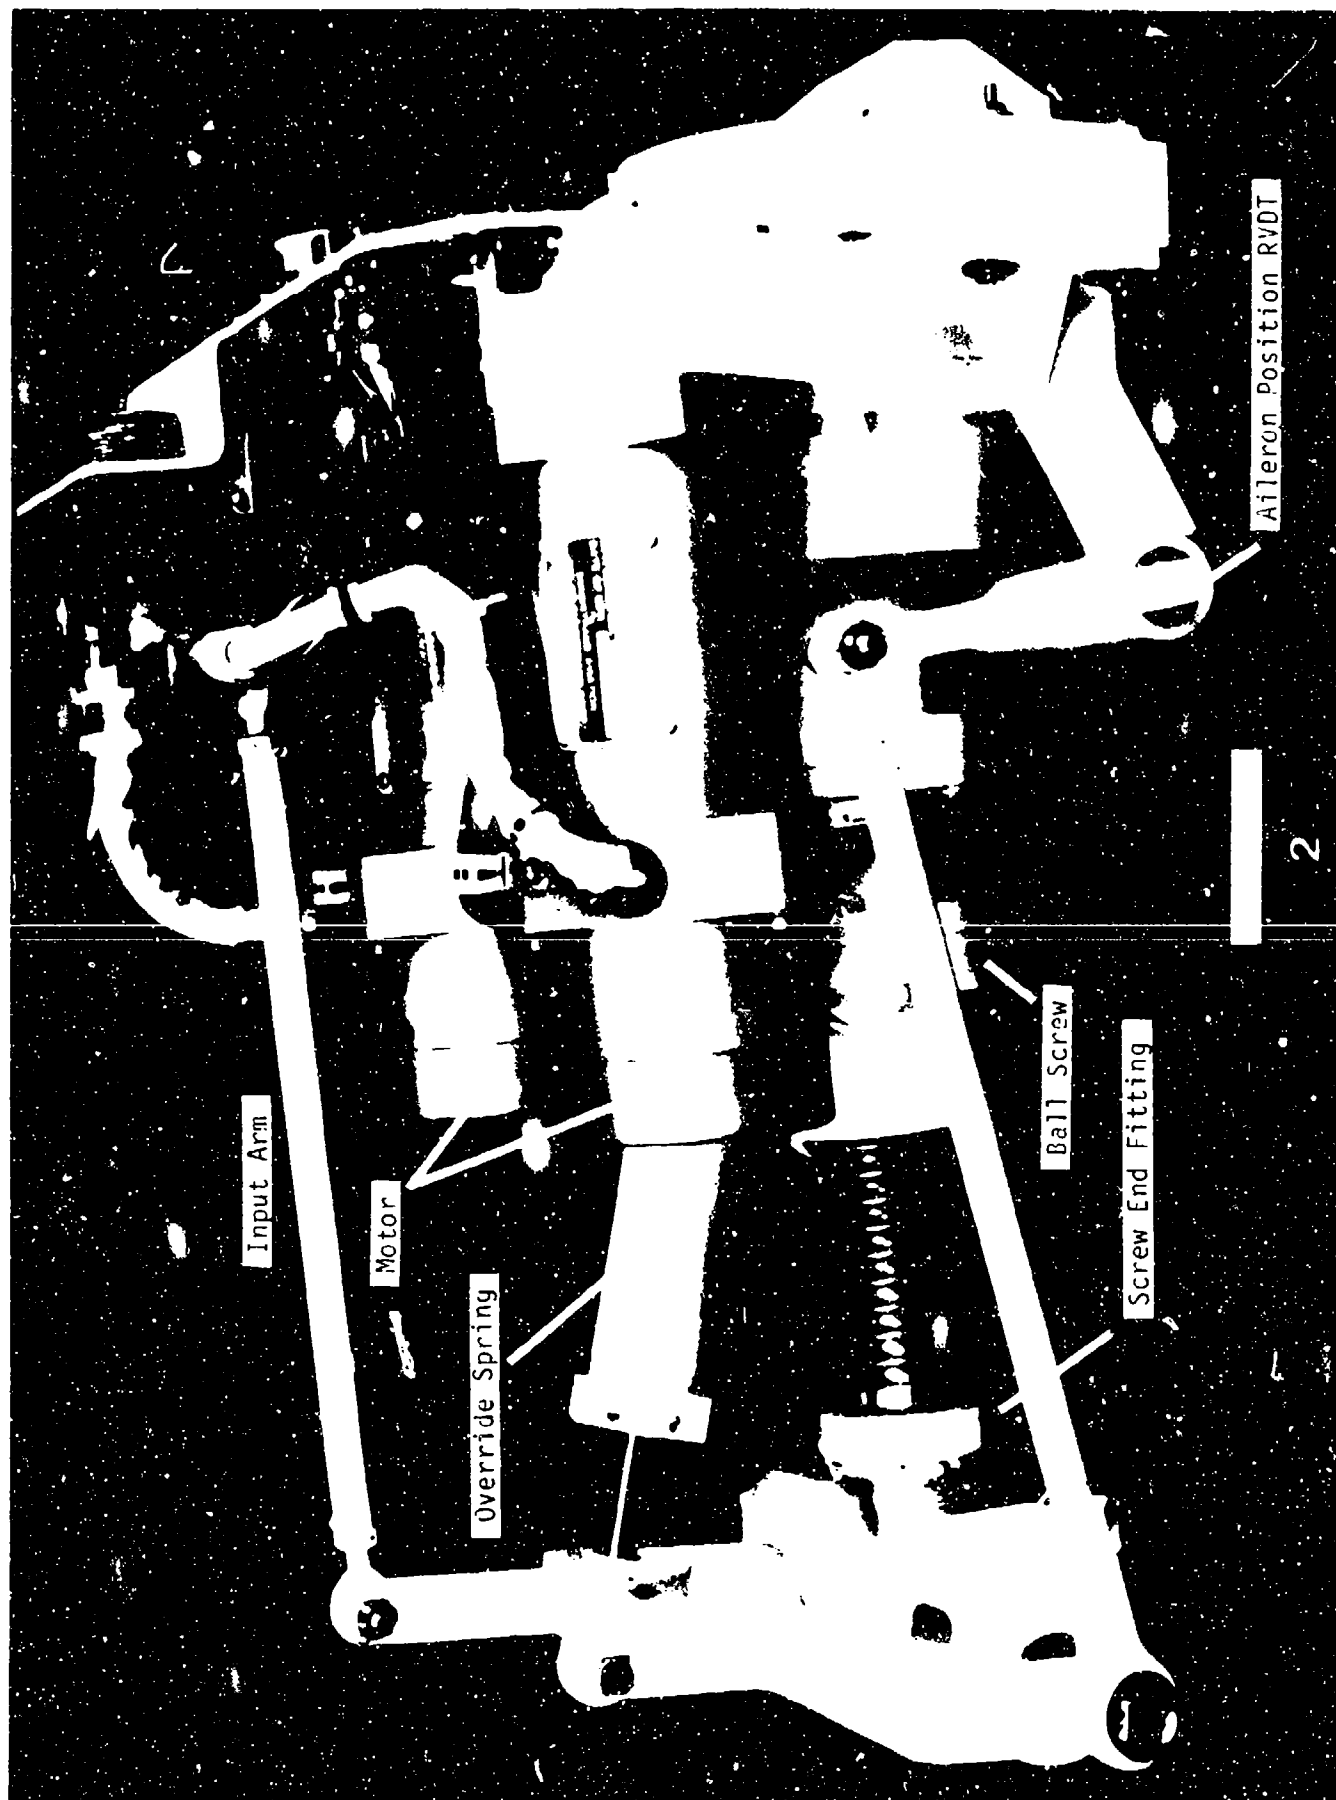
Figure 2-1 Electromechanical Actuator (EMA)

a. The advanced development model EMA (see Figure 2-1) weighed 65 pounds (lbs), six lbs heavier than the conventional hydraulic power control unit (PCU). This difference was caused primarily by an assembly that interfaces the single EMA ram with the existing dual ram connection, and the use of commercially available components and machined rather than cast hardware. The contractor predicted that a production version would weigh less than the hydromechanical unit. The EMAS dimensions are comparable to those of the PCU, fitting the actuator bay without structural modification. EMAS was designed to perform all of the functions of the original hydraulic actuator without altering the performance or stability and control of the aircraft. A listing of detailed EMAS technical data is given in Appendix D. The EMAS was a redundant dual channel unit (channel A and channel B) employing two electric motors, a gear train, and a linear ball screw assembly. A single motor is capable of effectively moving the aileron. The controller electronics (CE) provided the power to the EMA motors and processed all EMA signals, transmitted via a wire bundle between itself and the aileron actuator bay. The CE is contained in a double-bay Johnson rack (see Figure 2-2); however, a production unit would be reduced to a small box.

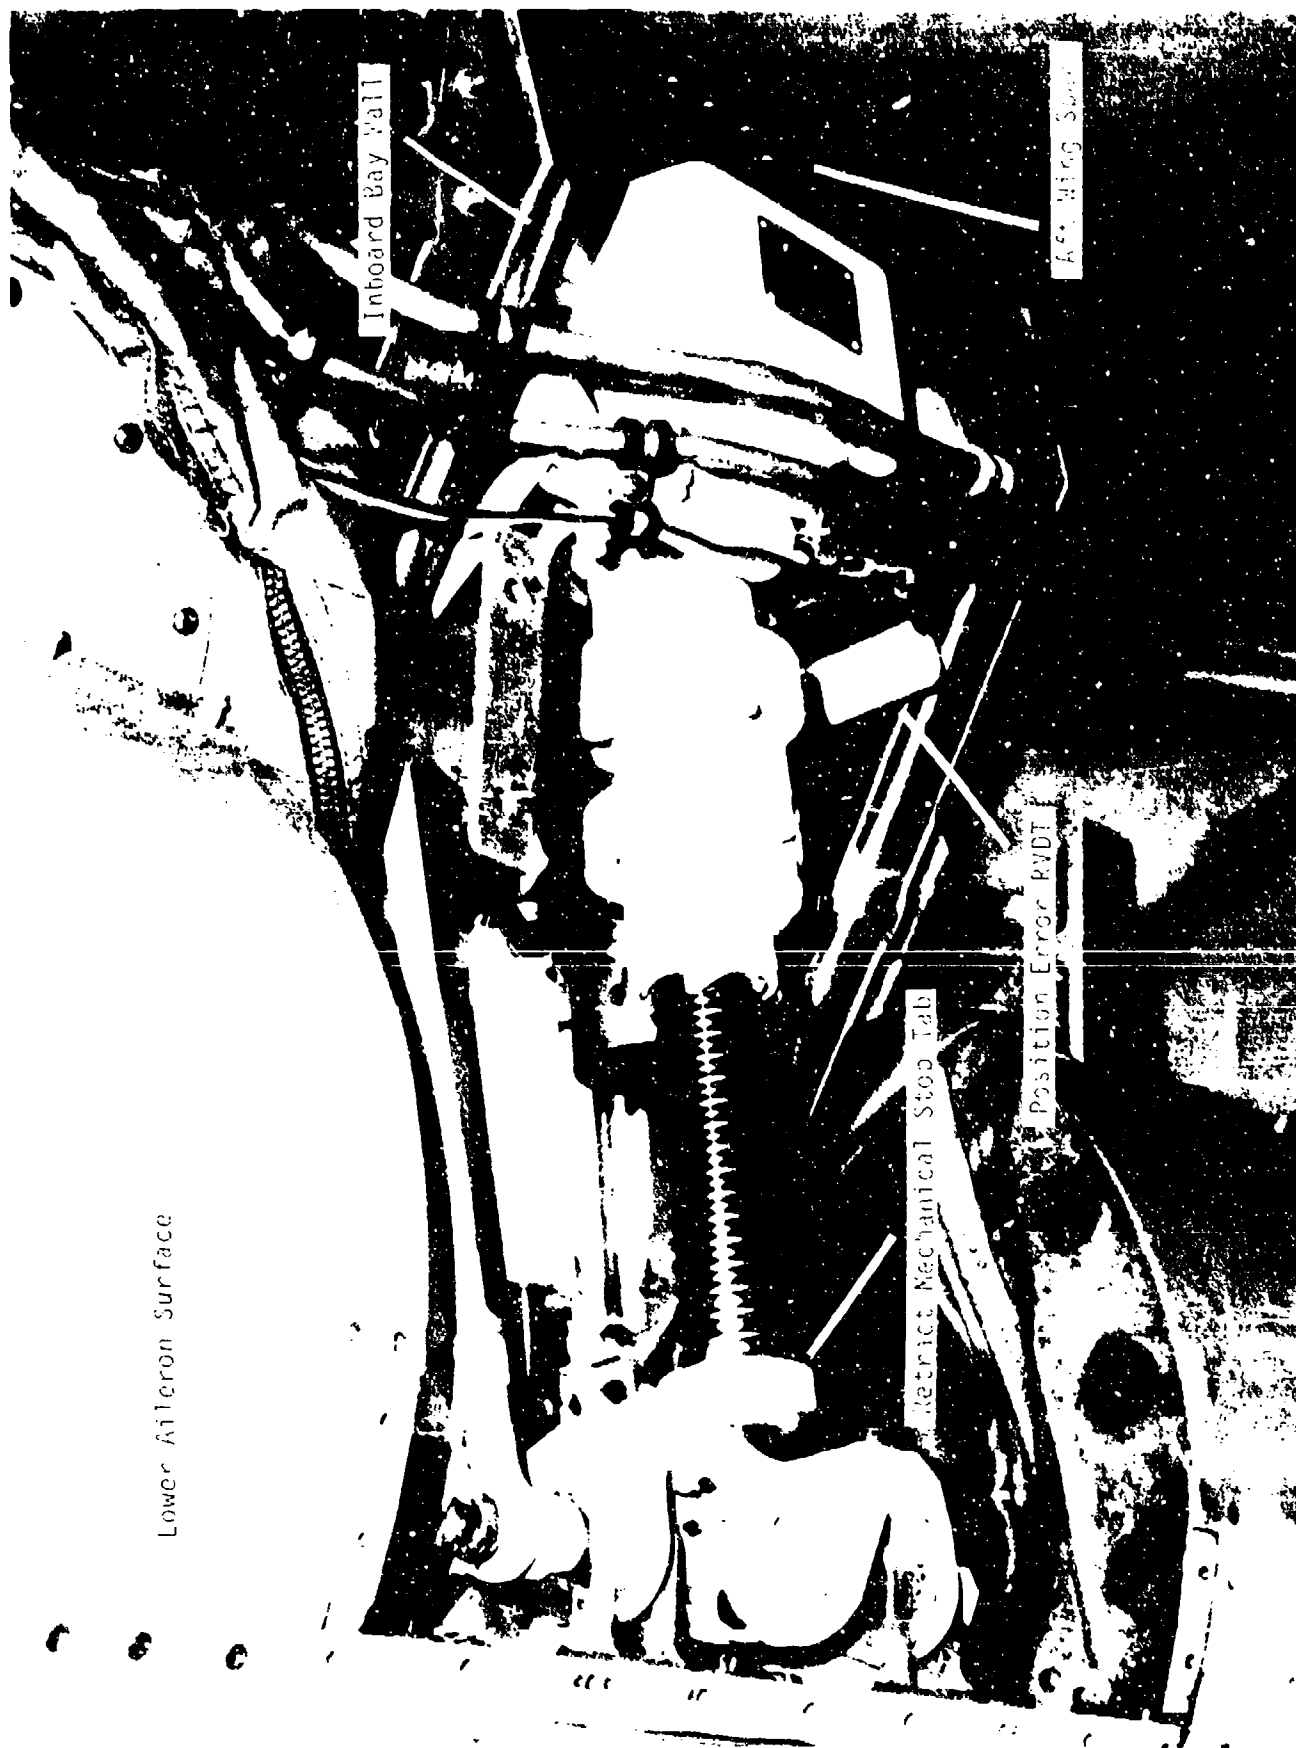
Figure 2-7 EMA Aircraft Installation

a. The EMA was designed as a "drop-in" replacement for the existing C-141 aileron actuator, requiring no structural modification to the aircraft (see Figure 2-7). It was compatible with the manual tab operable aileron system for emergency backup, and required no change to the autopilot, roll trim, or roll artificial feel systems. It utilized the existing flight control systems and monitoring functions and required no change to normal operating procedures. A modification profile is provided in Figure 2-8.

b. Sections of the unused PCU hydraulic lines in the actuator bay were removed and capped to provide room for the EMA. In order to permit backup tab operation of the left aileron in the event of total electrical system failure, the tab operable solenoid valve was connected to the Number 2 hydraulic system in place of the Number 3 system (see Figure 2-9). This valve ports hydraulic fluid to a tab operate cylinder, unlocking the tab lockout actuator and moving a tab input bellcrank from an over-center position to permit control commands to deploy the tab and assist in moving the aileron with aerodynamic forces. The Number 3 hydraulic system is electrically dependent whereas the Number 2 system is engine driven and would continuously provide pressure to the solenoid in the event of an electrical failure. In addition, a relay between the emergency DC bus and the isolated DC bus was installed to ensure an uninterrupted source for the 28 VDC power used to hold open the solenoid valve, thus ensuring that this function could be performed in the event of a total electrical system failure or if the crew should need to shut down the isolated bus as part of the electrical fire checklist procedure. A calibrated outside air temperature probe was added to the aircraft to provide a precise source for this parameter.

c. The EMA CE was placed in a double-bay "Johnson" rack. Electrical wire bundles from this rack and instrumentation wiring to the aileron actuator bays exited the pressurized cargo compartment through the life raft compartment inspection window apertures which were modified to provide a positive pressure seal. Life rafts were removed as a result of this modification.

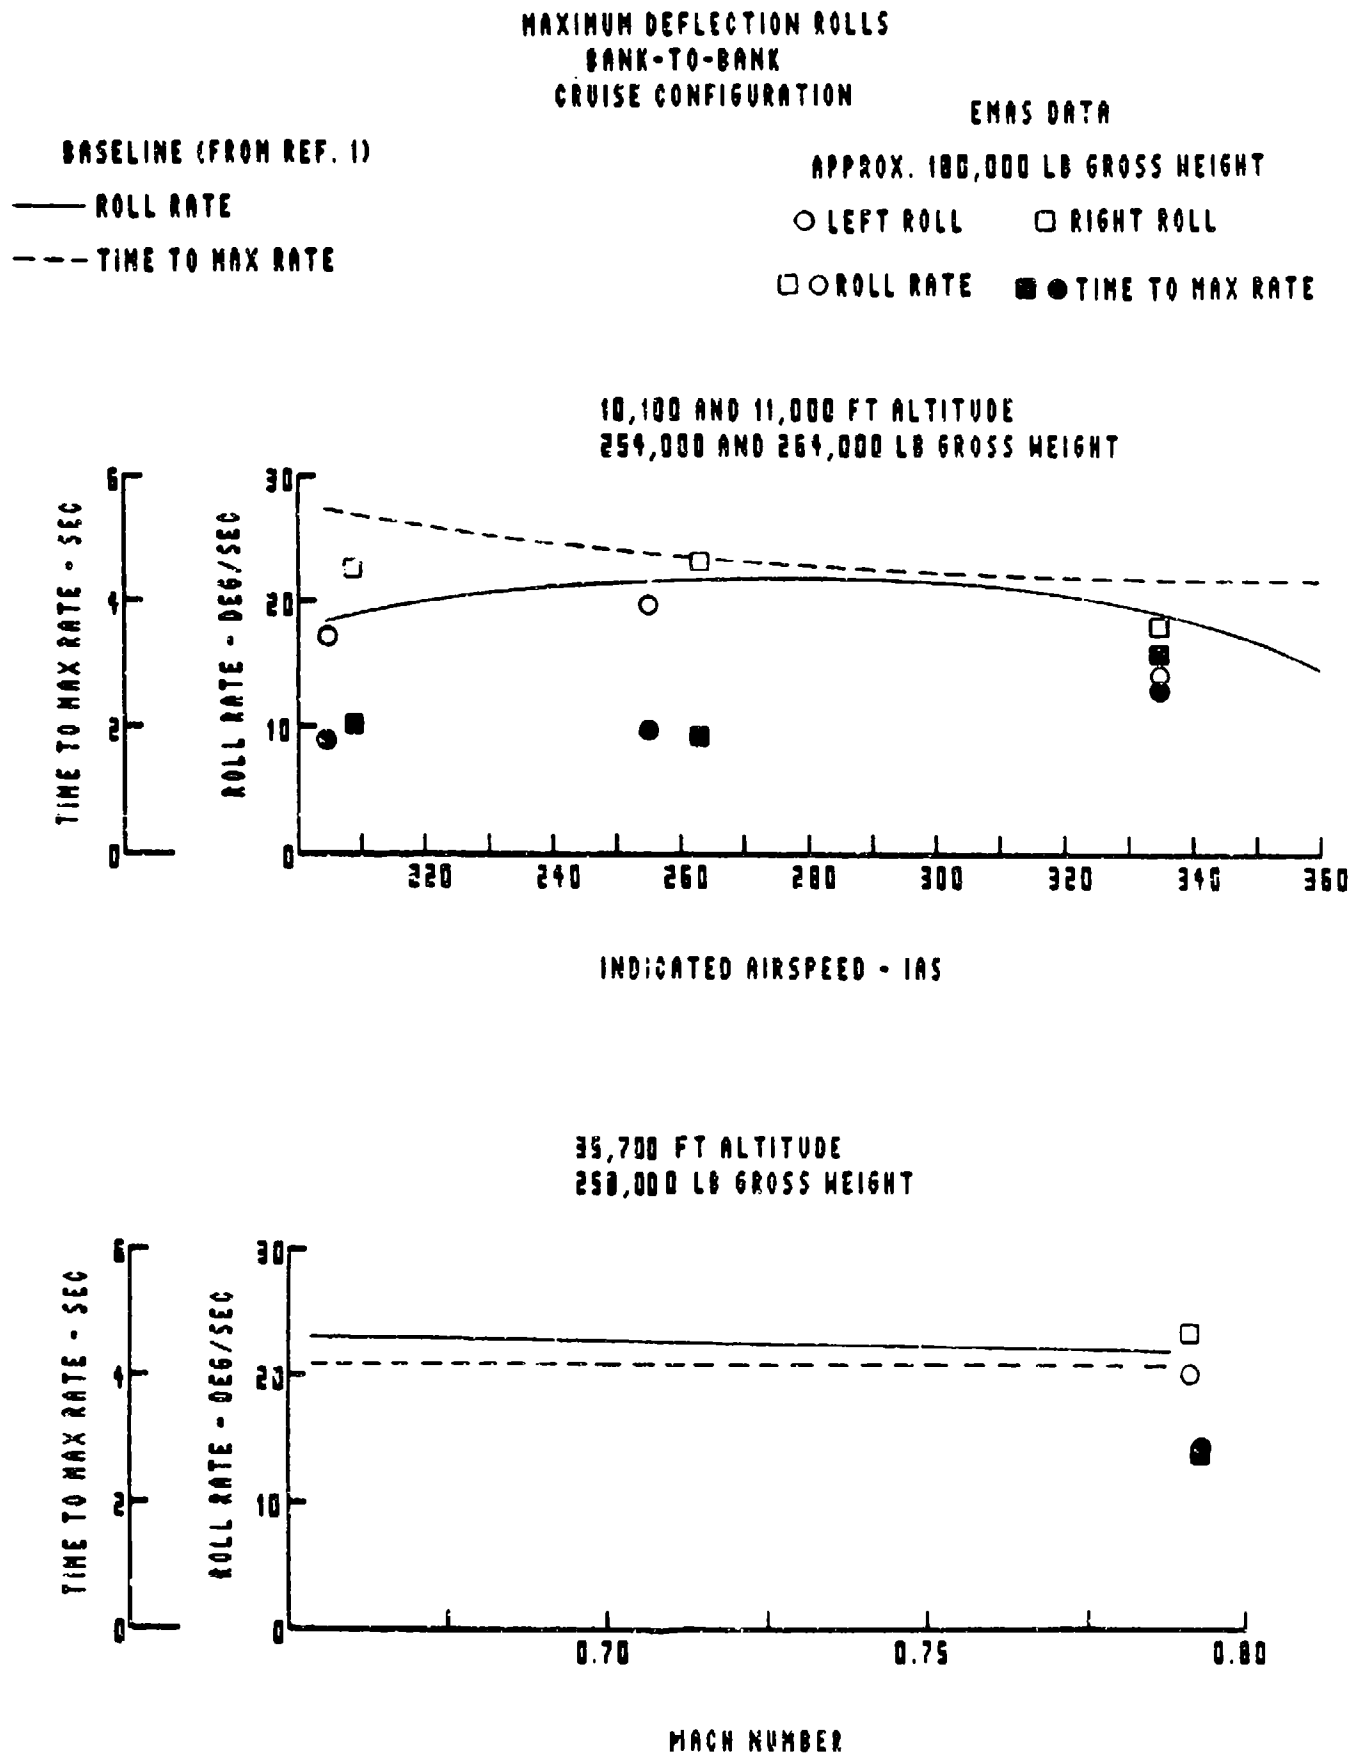
Figure 6-1 Baeeline/EMAS Roll Comparison

(2) Table 6-1 and examination of the maximum command roll time histories (see Figure A-2), reveal that the test aircraft rolled at a faster rate to the right than to the left. It is also apparent that the left aileron usually failed to reach the same aileron deflection as the right aileron for similar maneuvers and test conditions. This is attributable to the inability of the EMA to reach the normal aileron travel limits. Most maneuvers succeeded in driving the right aileron to the travel limits, so the left aileron would also be expected to reach the limit in the opposite direction. With the lower end travel deflection rate of the left aileron and the greater end travel deflection angle of the right aileron, the ailerons were consistently off the normal travel schedule near the end of travel. This resulted in a positive yaw rate in rolls in both directions, or proverse yaw in rolls to the right and adverse yaw in rolls to the left. Thus, right rolls had a higher roll rate than left rolls. When EMAS test data is compared with limited baseline data (see Figure 6-1, B-1, and B-2), right rolls are generally higher and left rolls lower than predicted. The difference in the time to maximum deflection angle from the baseline is attributed to the lower EMAS test aircraft gross weight. The average gross weight for all test points was 180,000 lbs, not varying by more than 15,000 lb during the course of a test, with an average mean aerodynamic chord center of gravity location of 31.0%. The inability of the EMAS to produce similar performance to the hydromechanical system was the result of the more pronounced slow down feature and the inability to reach the maximum travel limits. These departures from the baseline roll performance were not detectable by the pilots.

15. Right rolls occurred at a higher rate than left rolls and also higher than baseline roll rates for maximum command roll inputs. Left rolls were at a lower rate than baseline. This is attributable to the lower deflection rate of the left aileron near the travel limit and the failure of the EMAS to produce the maximum aileron travel.

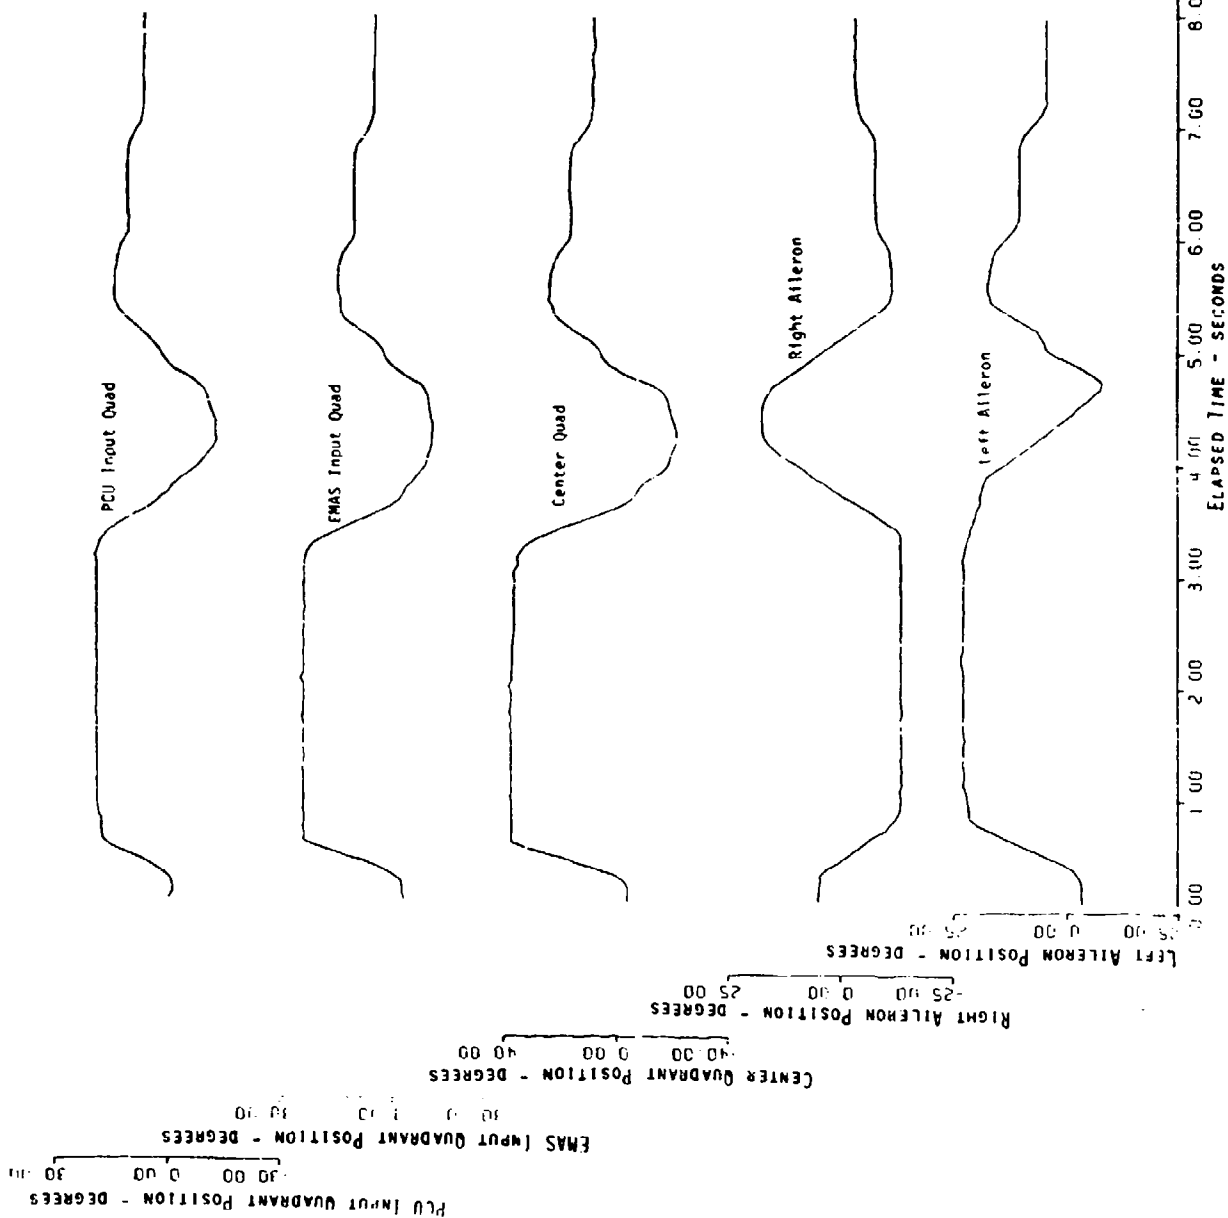
Figure A-3.2a
CONTROL SYSTEM RESPONSE

Bank-to-Bank

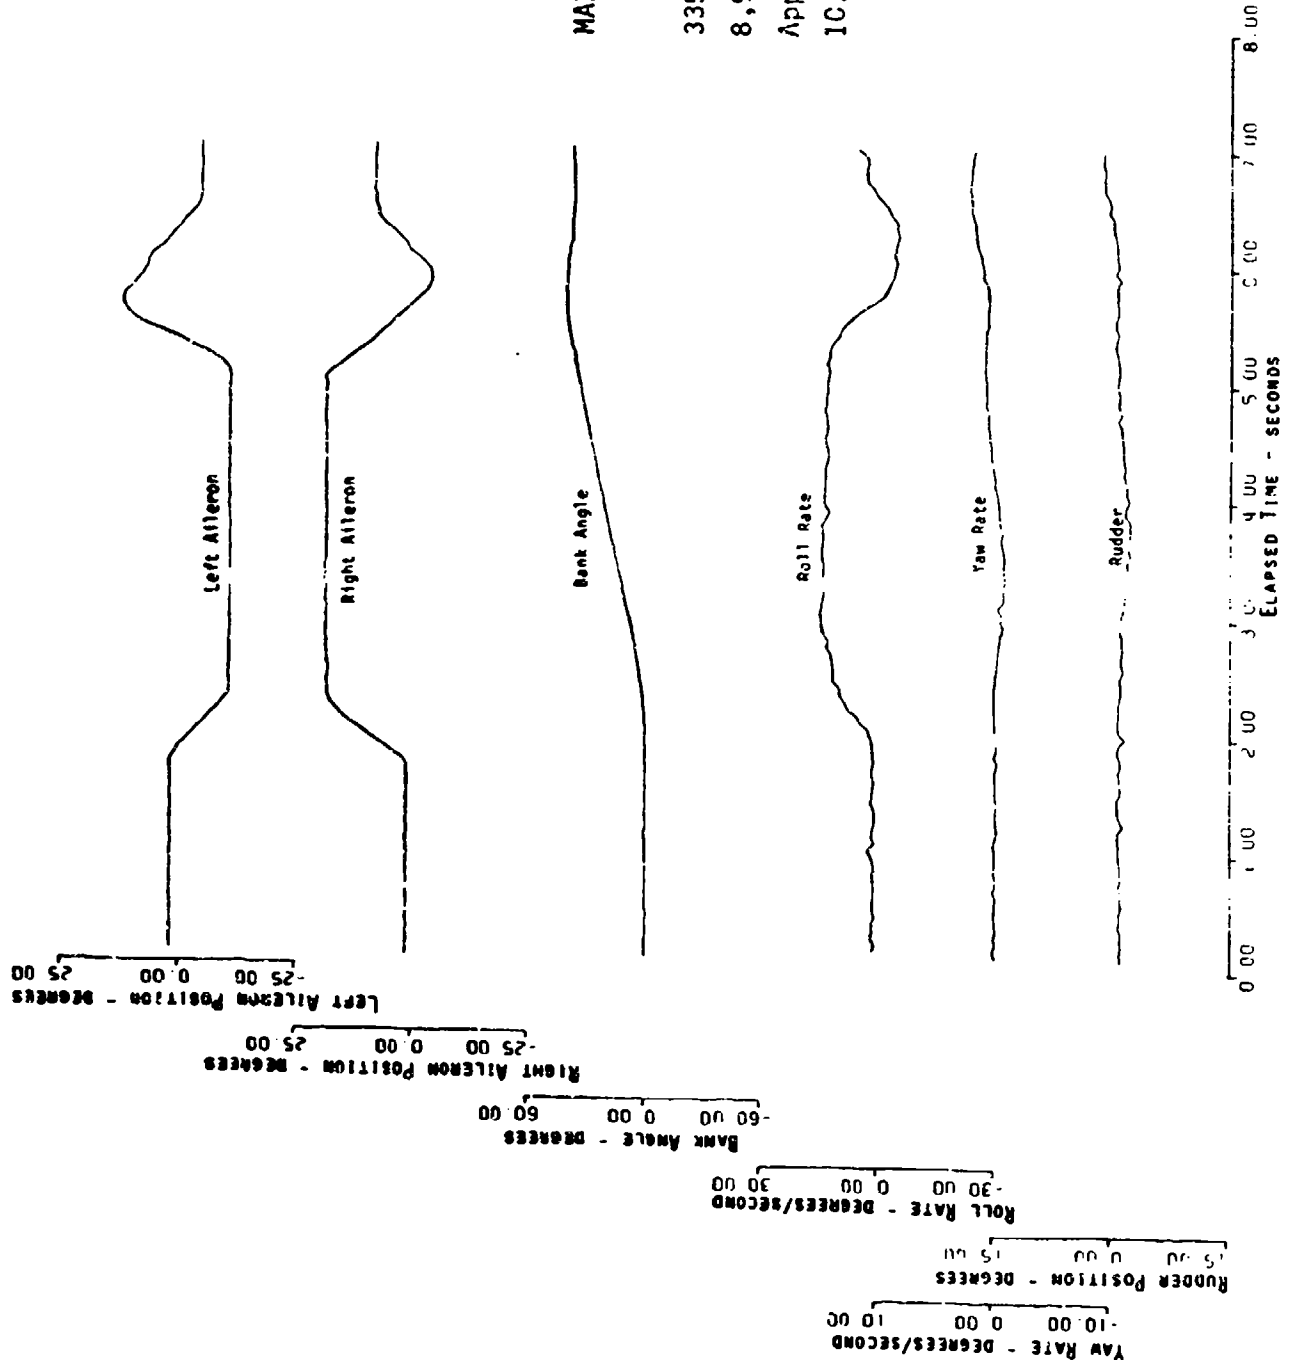
Figure A-5.2a
 MAXIMUM DEFLECTION DEGRADED ROLL
 Chan B & Sys 2 Off
 335 kts Airspeed
 9,000 ft Altitude
 Approx. 180,000 lb G.W.
 10.7° C OAT

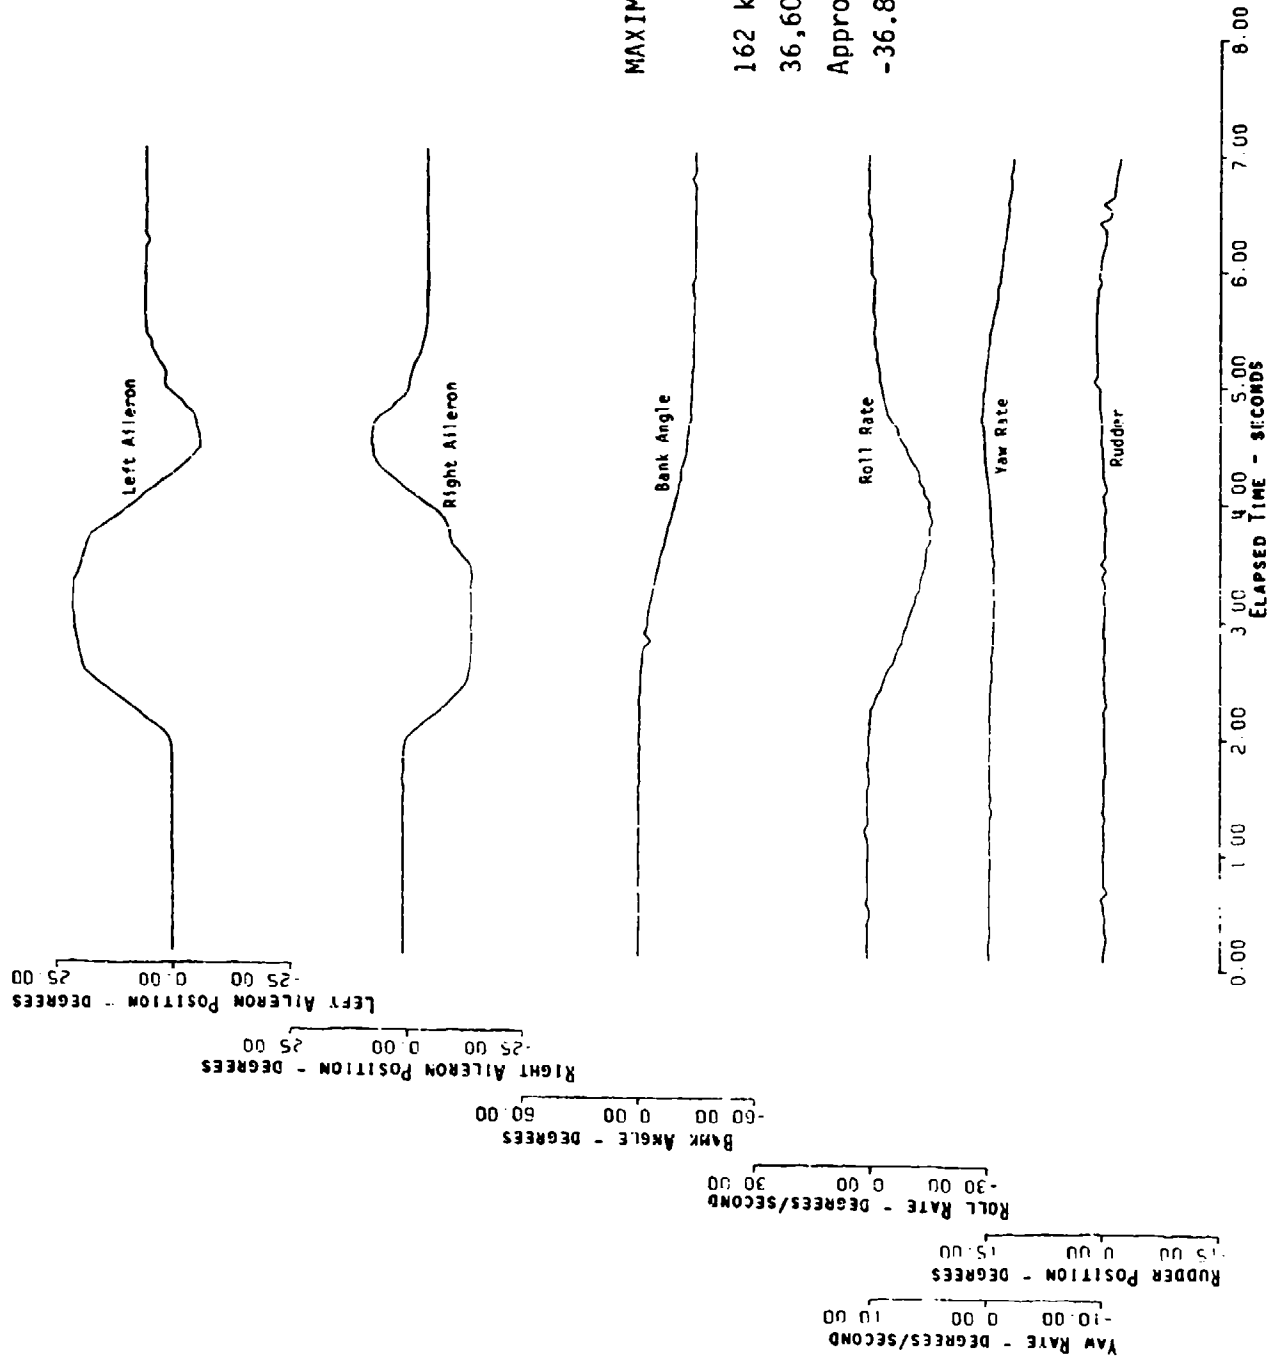
Figure A-5.4a
 MAXIMUM DEFLECTION DEGRADED ROLL
 Chan B & Sys 2 Off

162 kts Airspeed
 36,600 ft Altitude
 Approx. 180,000 lb G.W.
 -36.8° C OAT

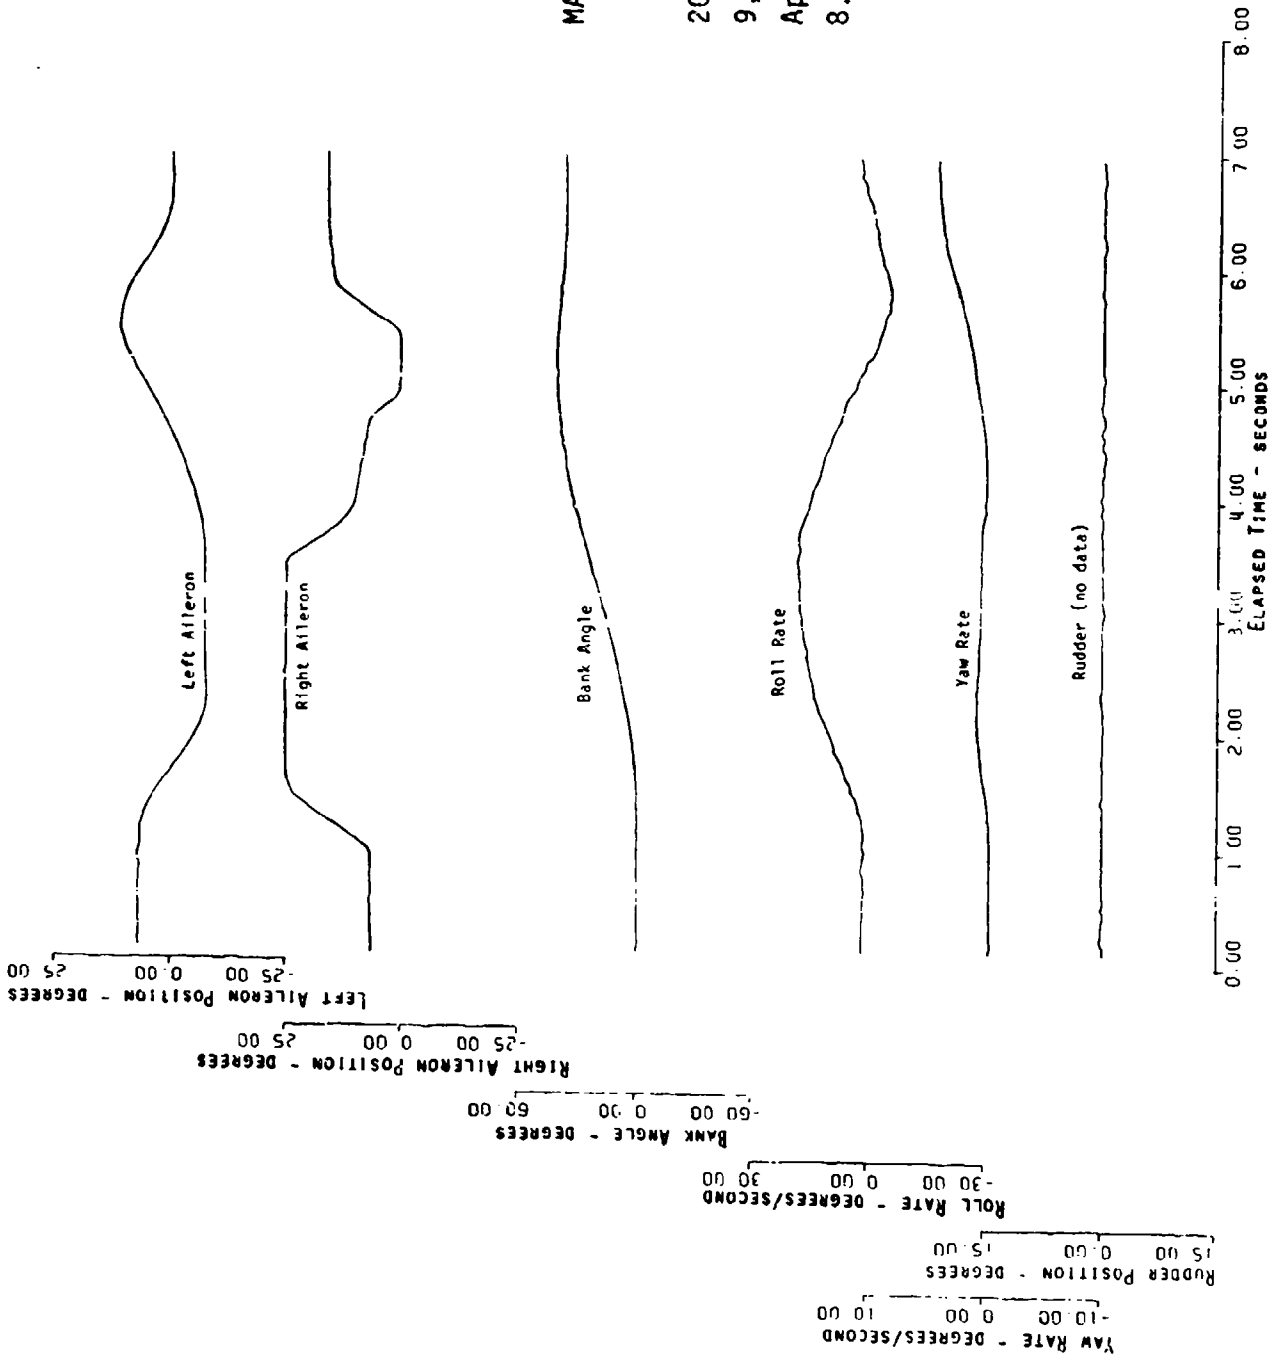
Figure A-6.2a
 MAXIMUM DEFLECTION TAB ROLL
 Right Tab
 202 kts Airspeed
 9,300 ft Altitude
 Approx. 180,000 lb G.W.
 8.5° C OAT

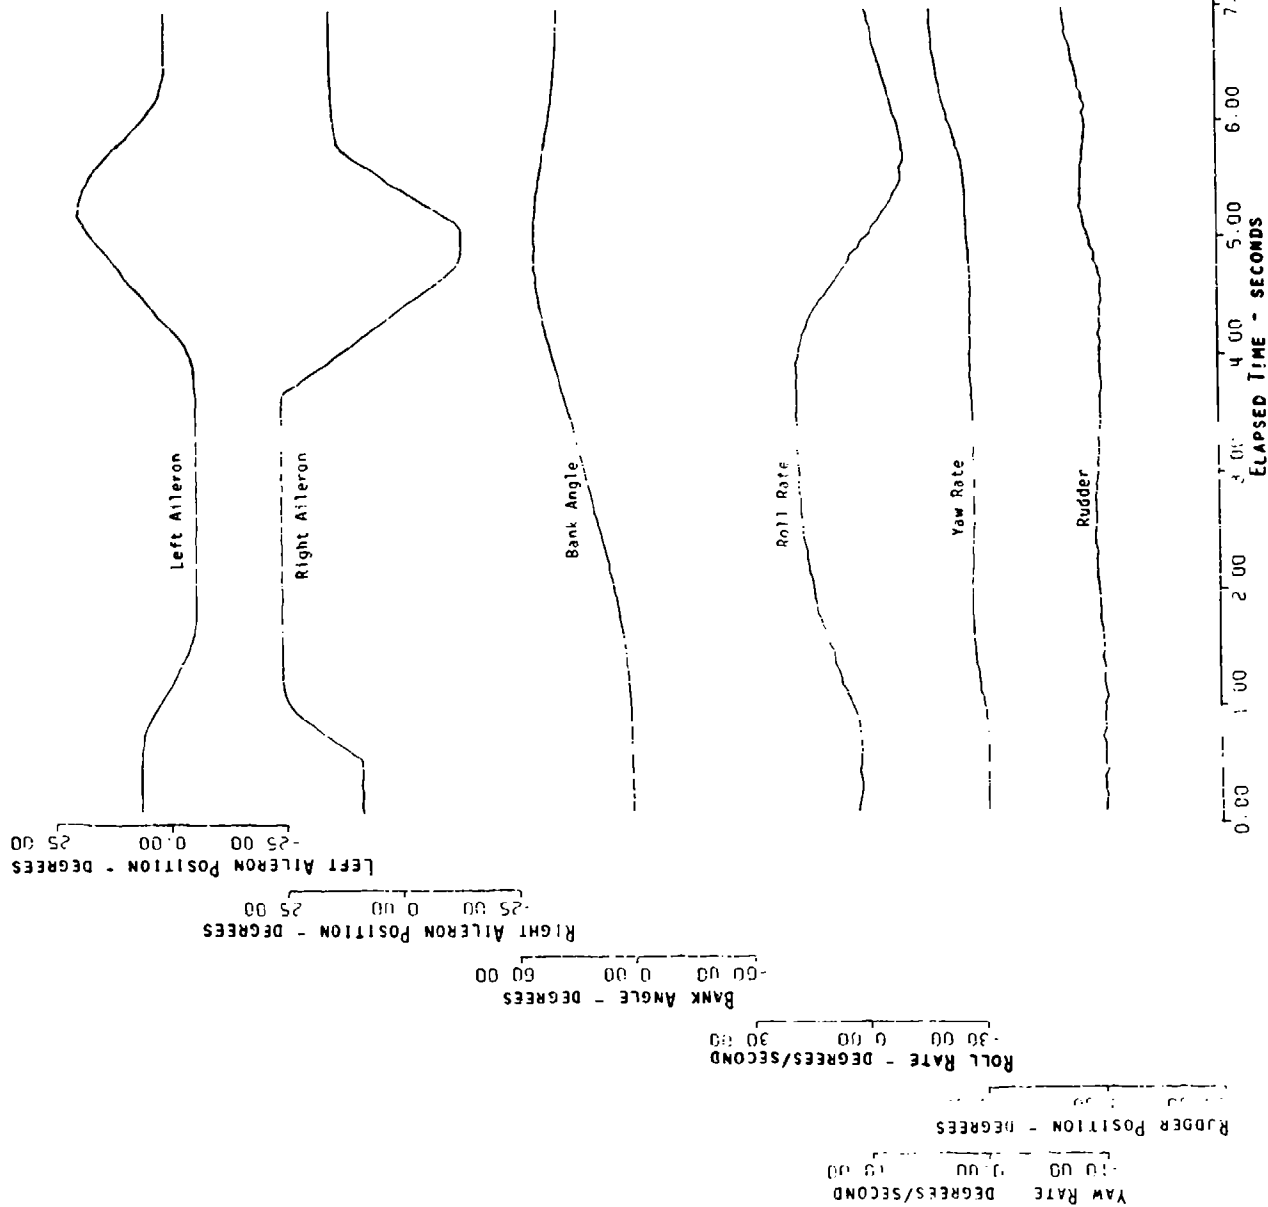
Figure A-6.3b
 MAXIMUM DEFLECTION TAB ROLL
 Left Tab
 188 kts Airspeed
 20,300 ft Altitude
 Approx. 180,000 lb G.W.
 -23.8° C OAT

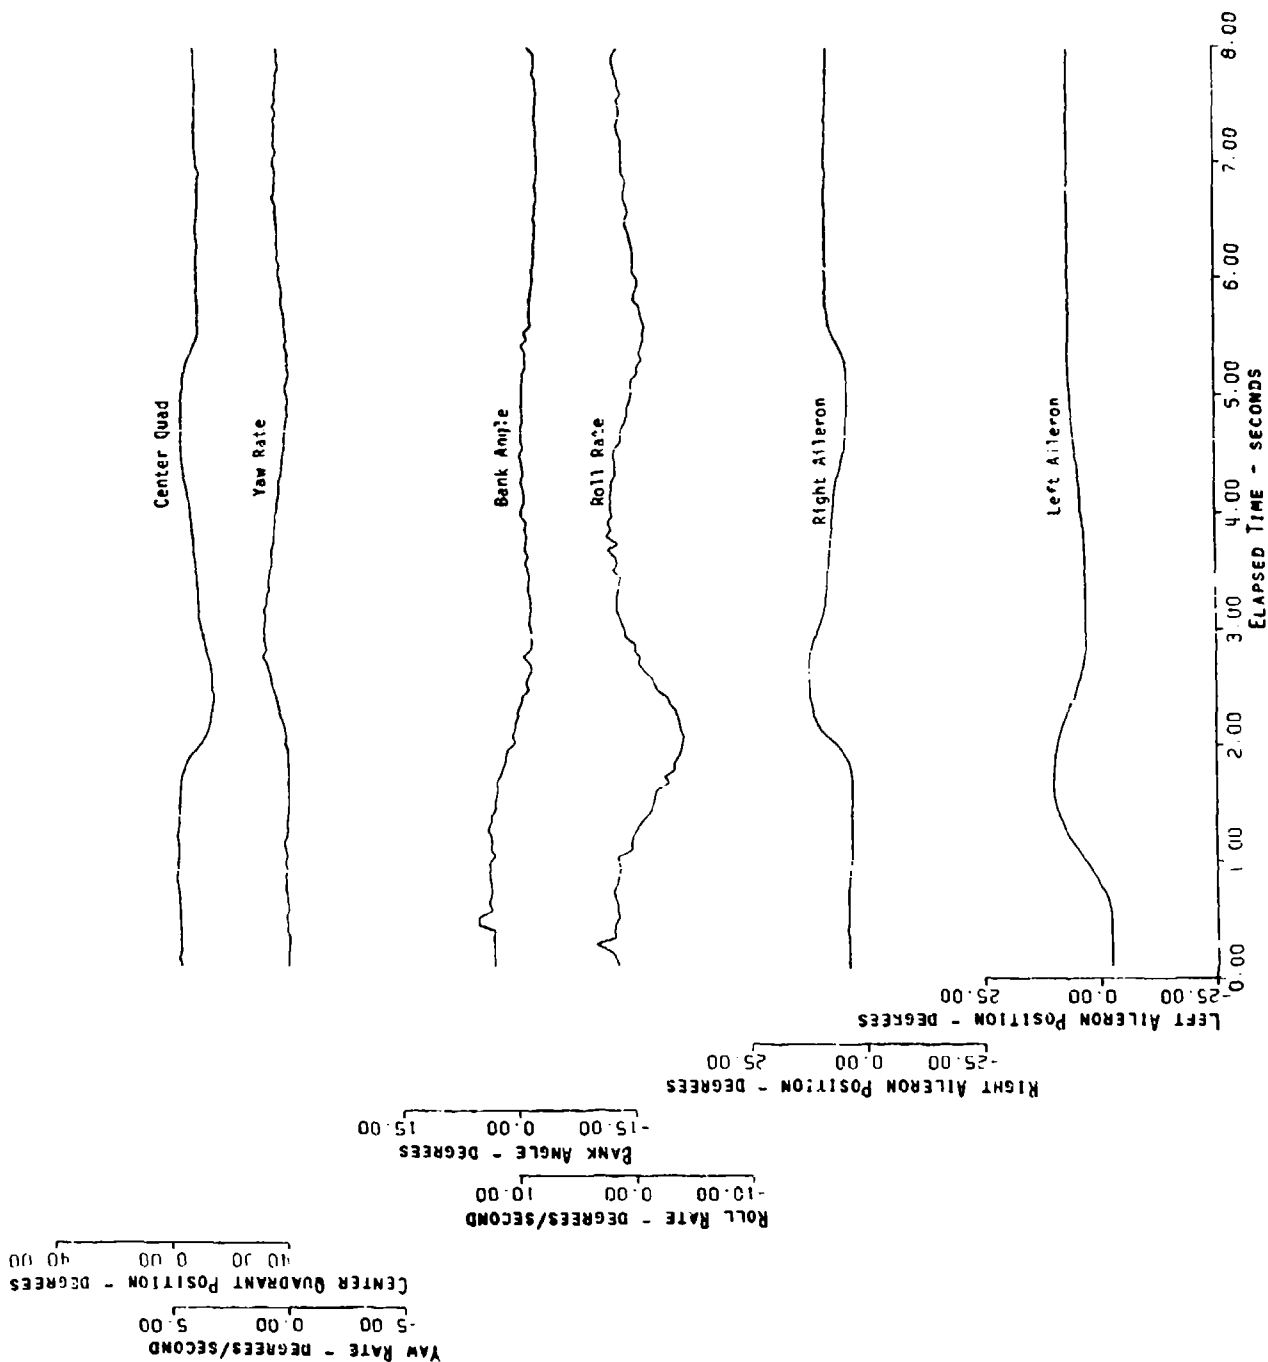
Figure A-7.2a
 TAB OPERABLE ROLL-OFF
 Left Tab Unlock
 202 knots Airspeed
 9,200 ft Altitude
 Approx. 180,000 lb G.W.
 8.5° C OAT

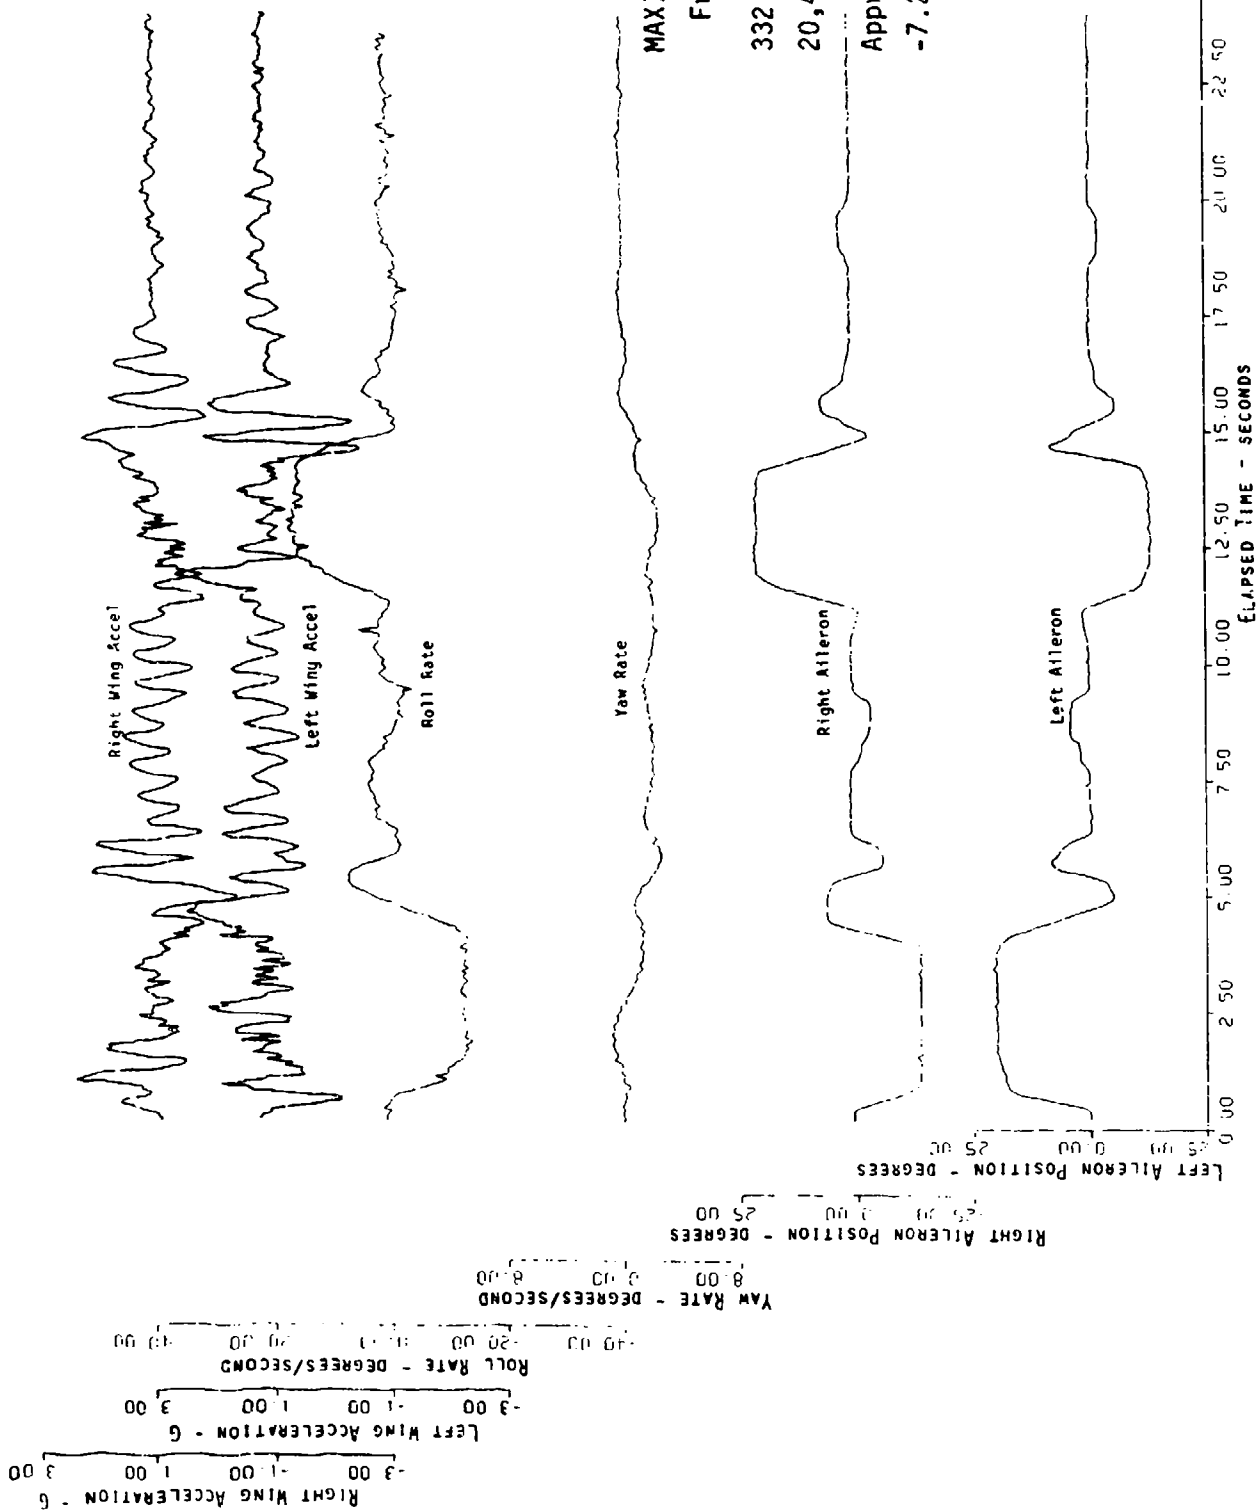
Figure C-2a

MAXIMUM DEFLECTION ROLL

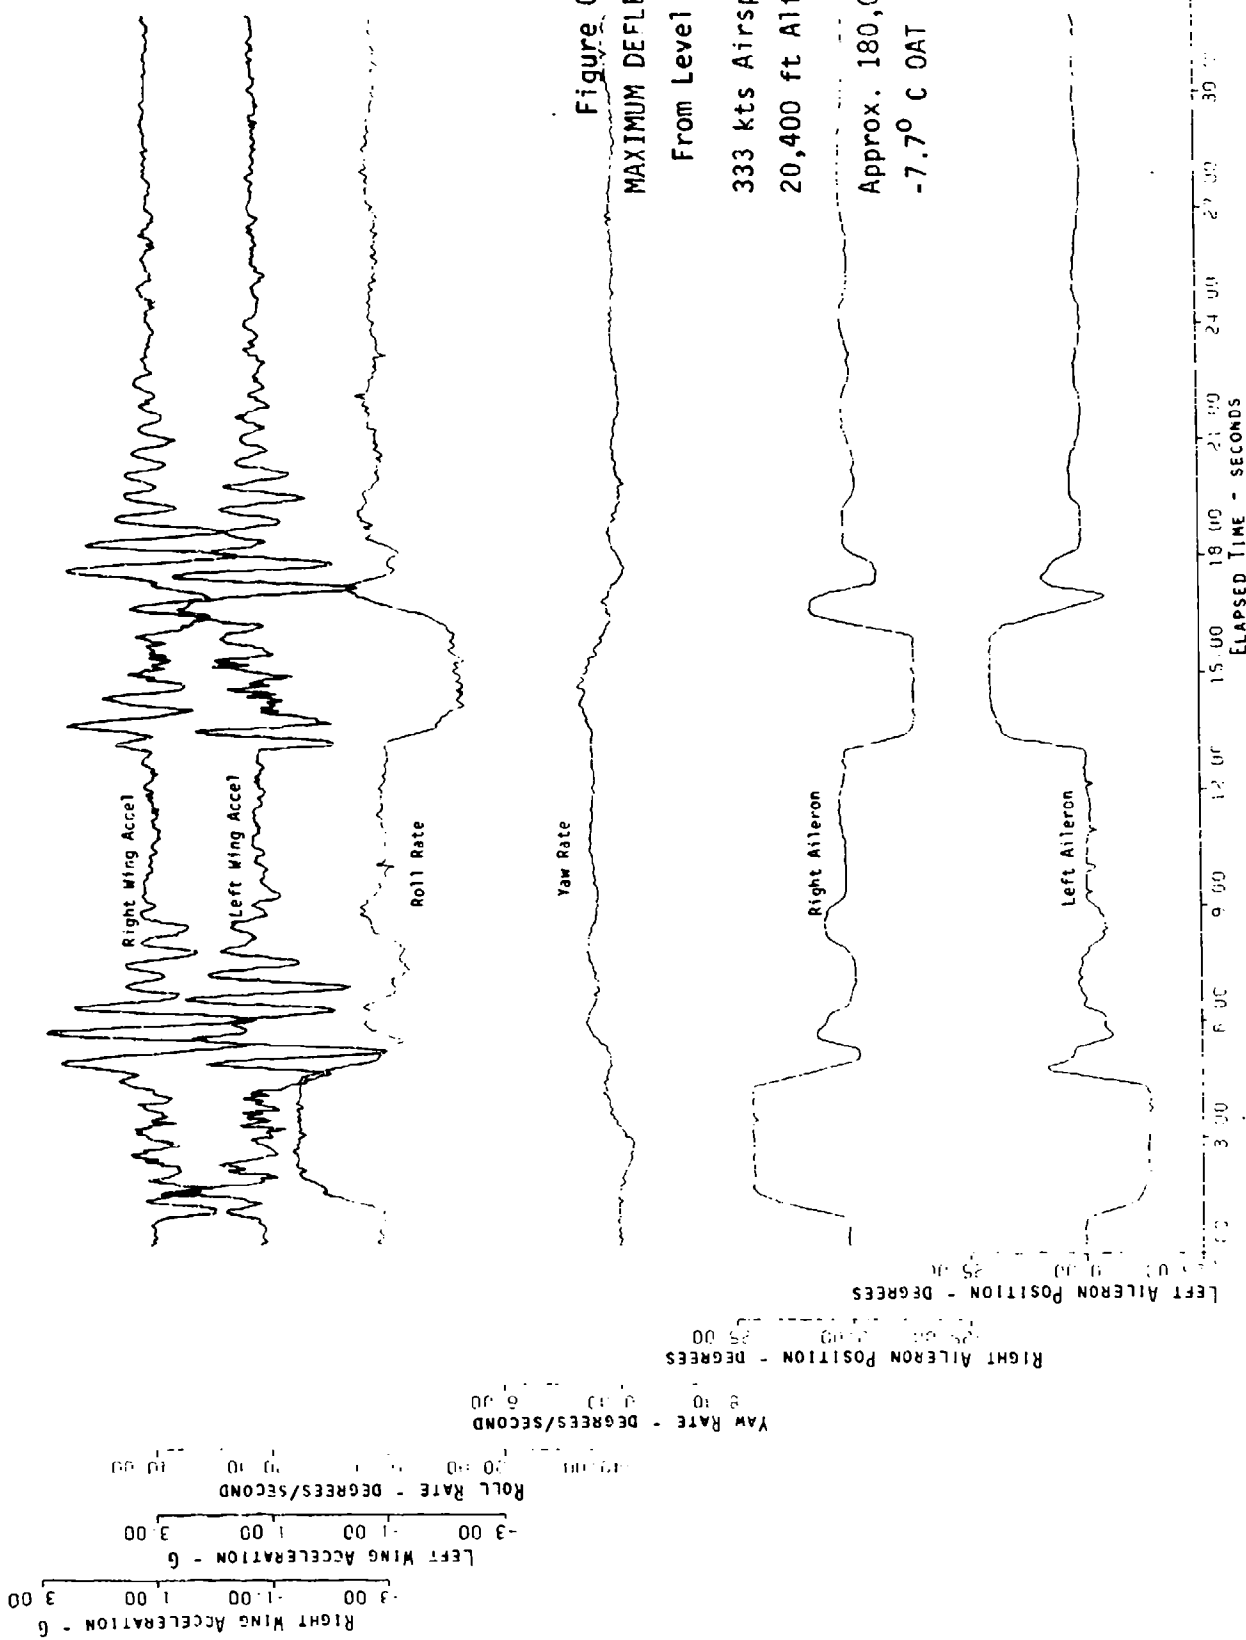
Figure C-2b
 MAXIMUM DEFLECTION ROLL
 From Level and Back
 333 kts Airspeed
 20,400 ft Altitude
 Approx. 180,000 lb G.W.
 -7.7° C OAT
